**JET FIRE TEST REPORT OF CONCRETE SLAB PROTECTED WITH INSULATING
MATERIAL U STUCCO-FRX**

TEST DATE : 07/10/2023
LOCATION : Amguri Field, Assam
COMPANY : Oilmax Energy Pvt Ltd.
OPERATION IN-CHARGE : A.K. Singh (Senior-VP, OEPL)
PROJECT COORDINATOR : Shubham Singh (Senior Engineer, OEPL)
M/s SMARK INFRASTRUCTURE: Sujay Shah (MD - Smark Infrastructure)
REPRESENTATIVE

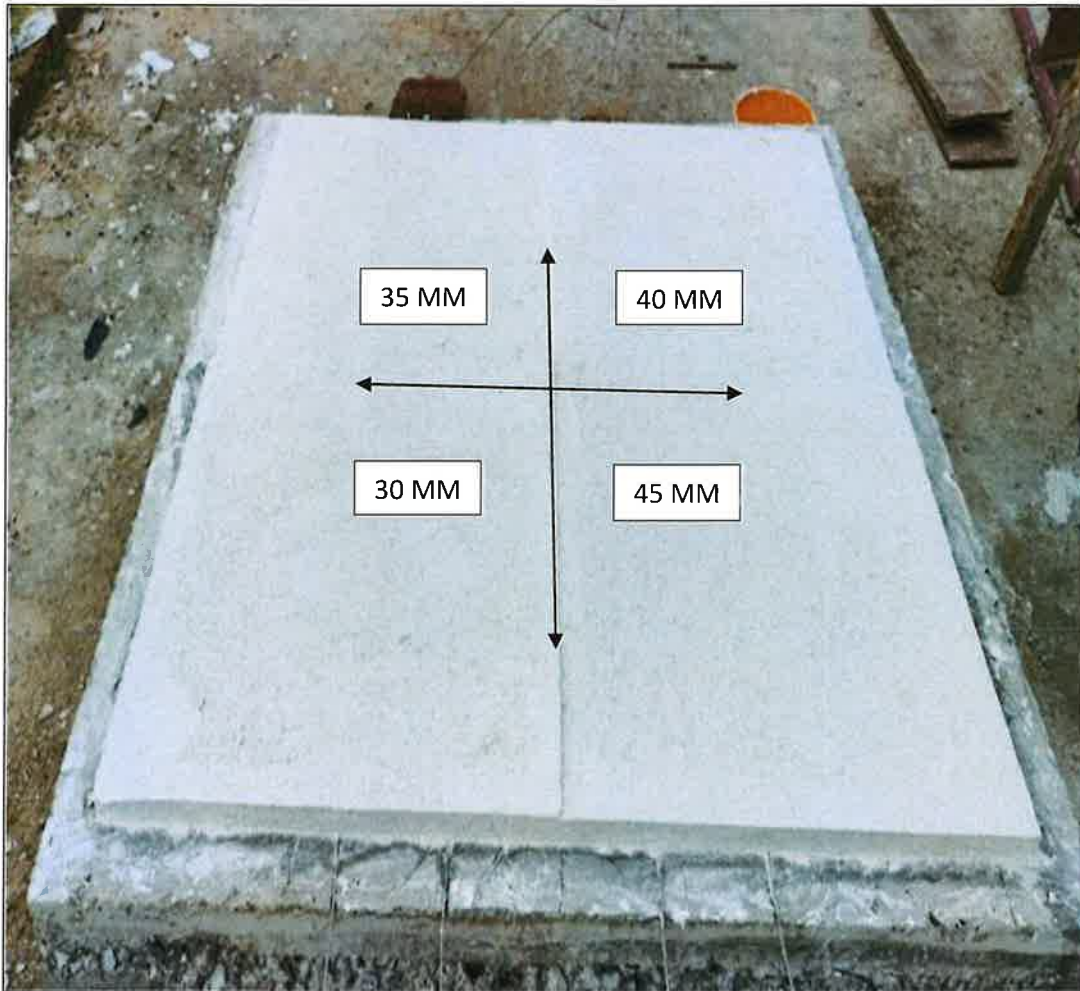
Figure 1: Construction details of Concrete slab protected with insulating material U Stucco-FRX

The test specimen consists of concrete slab of 1620 mm X 1620 mm size, protected with insulating material, U Stucco-FRX. The slab was divided into four equal quadrants and on each quadrant, U Stucco-FRX insulating material was applied in different thickness as shown in Figure 1.

Before application of the material total eight thermocouples were fixed, with two in each quadrant of the concrete slab.:

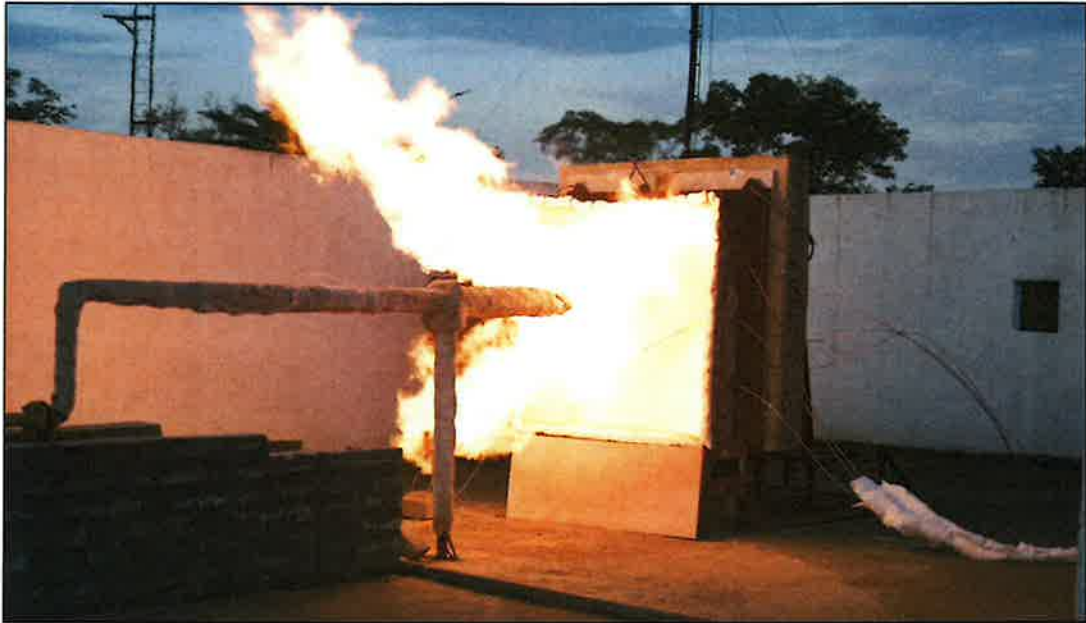
Figure 1: Jet fire resistance test at Amguri field, Assam

The specimen is tested as per the procedure defined in ISO 22899 using natural gas. The test set-up is depicted in Figure 1. During the fire exposure the temperature on the exposed side of the specimen was recorded at different locations as shown in Figure 2.

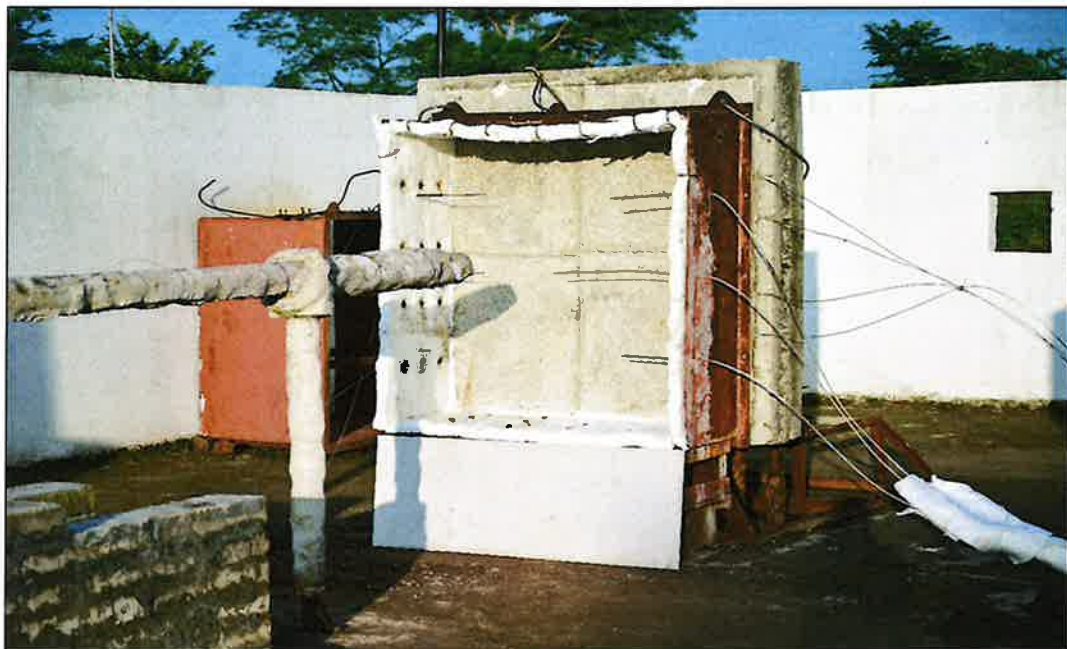
Figure 2: Thermocouple location on the exposed side of specimen

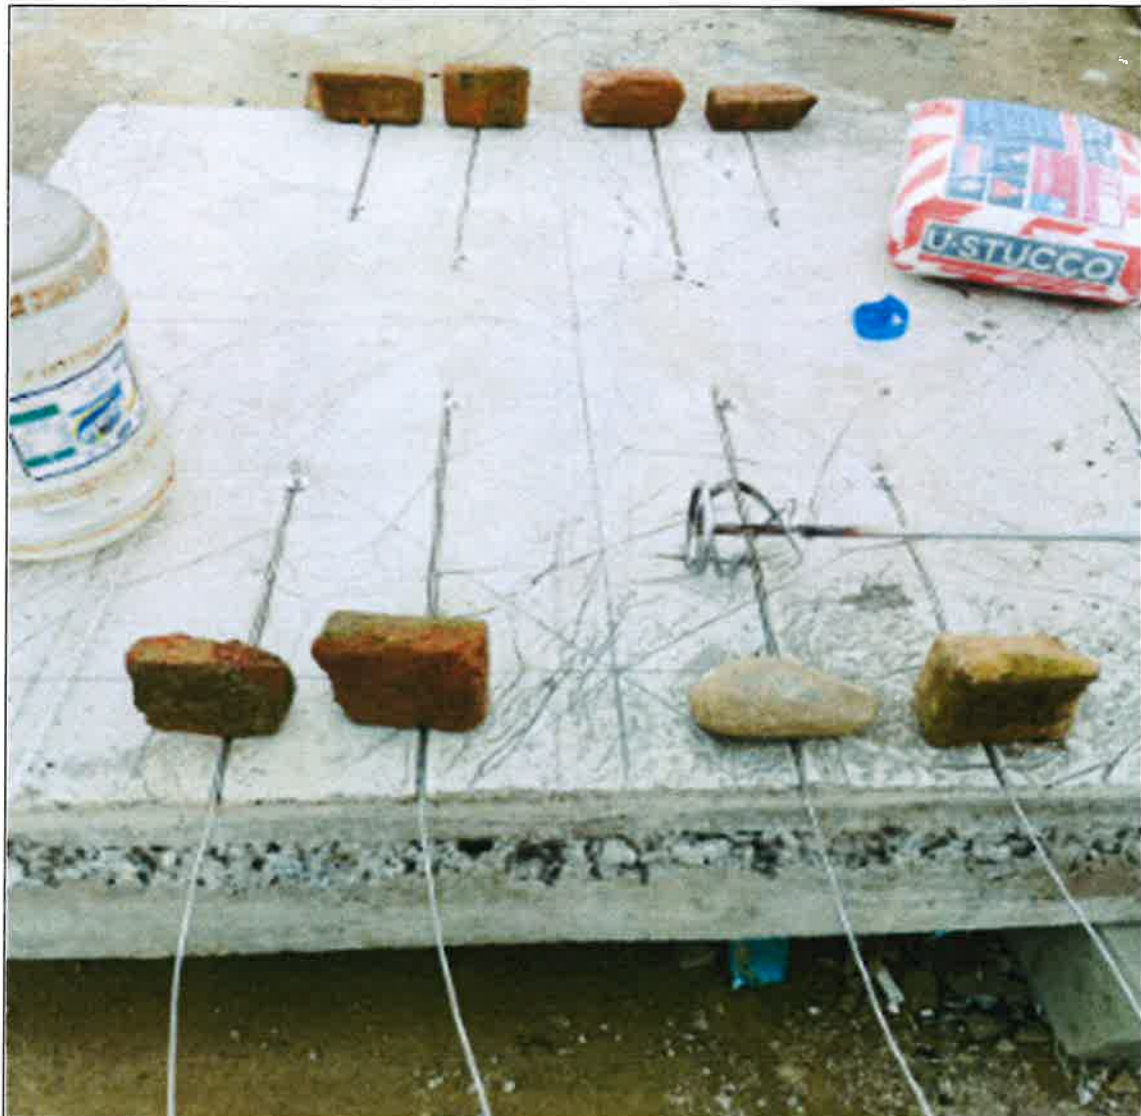
Figure 3: Thermocouple location of the test specimen

During the fire exposure, temperature on the surface of concrete protected with U Stucco-FRX material was measured at different locations as shown in Figure 3.

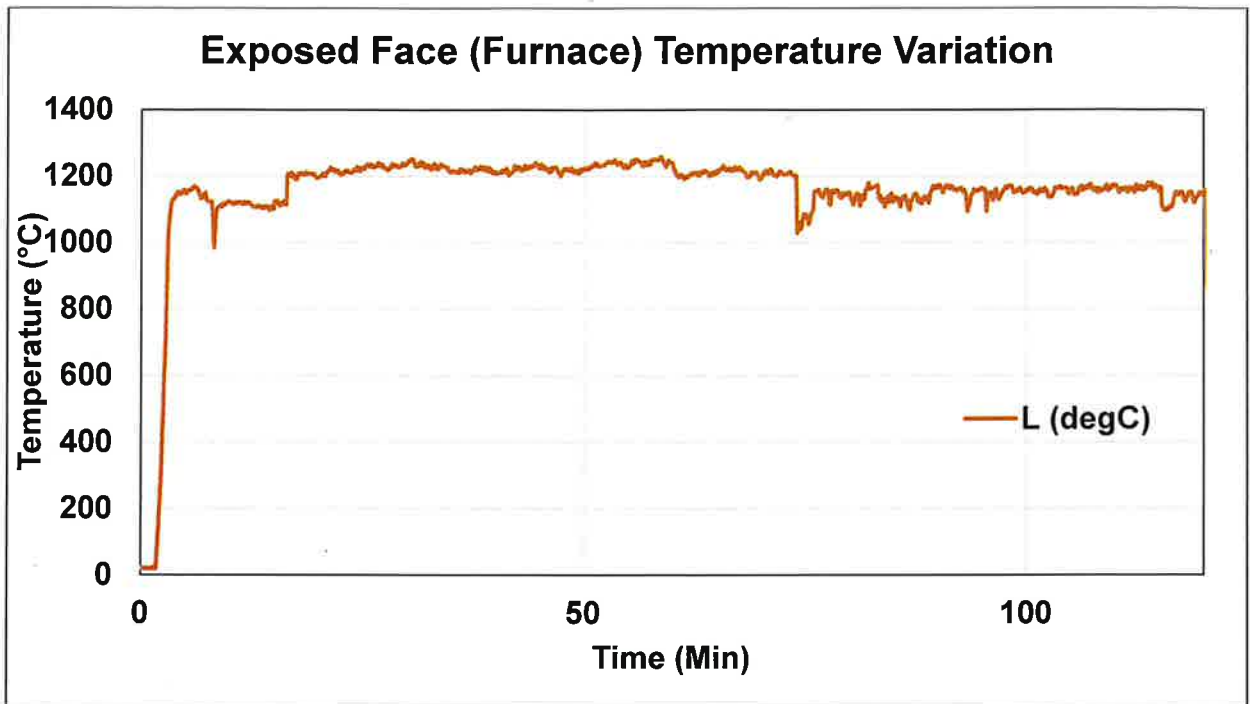
Figure 4: Temperature variation of the flame re-circulation temperature Concrete slab protected with insulating material U Stucco-FRX

The temperature variation of the flame re-circulation temperature of concrete slab protected with insulating material U Stucco-FRX is plotted in Figure 4

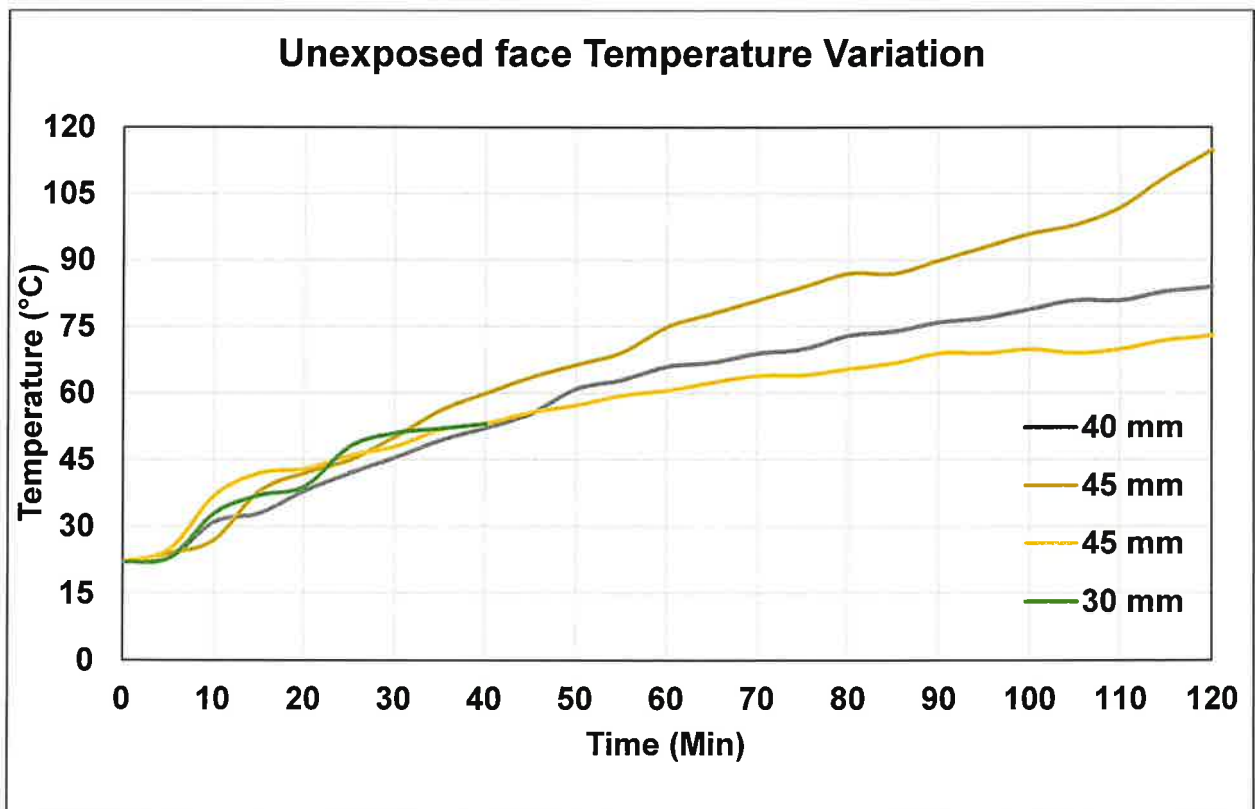
Figure 5: Unexposed side temperature variation of Concrete slab protected with insulating material U Stucco-FRX

The variation of the temperature on the surface of concrete protected by different thickness of the U Stucco-FRX protection material as recorded during fire exposure is given in Table 1 and plotted in Figure 5.

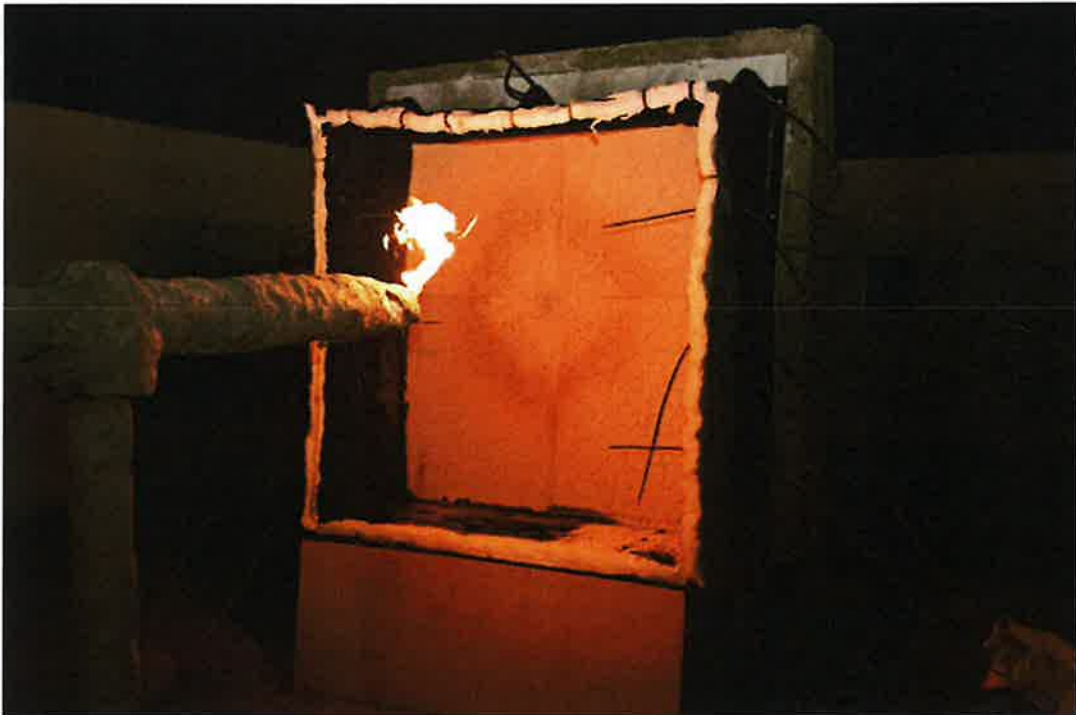
Figure 6: Condition of exposed face after fire exposure

- During fire exposure no spalling puffing was observed on the protection material.as shown in Figure 6 and 7.
- After 120 minutes of jet fire exposure no spalling puffing was observed on the protection material.as shown in Figure 6 and 7.

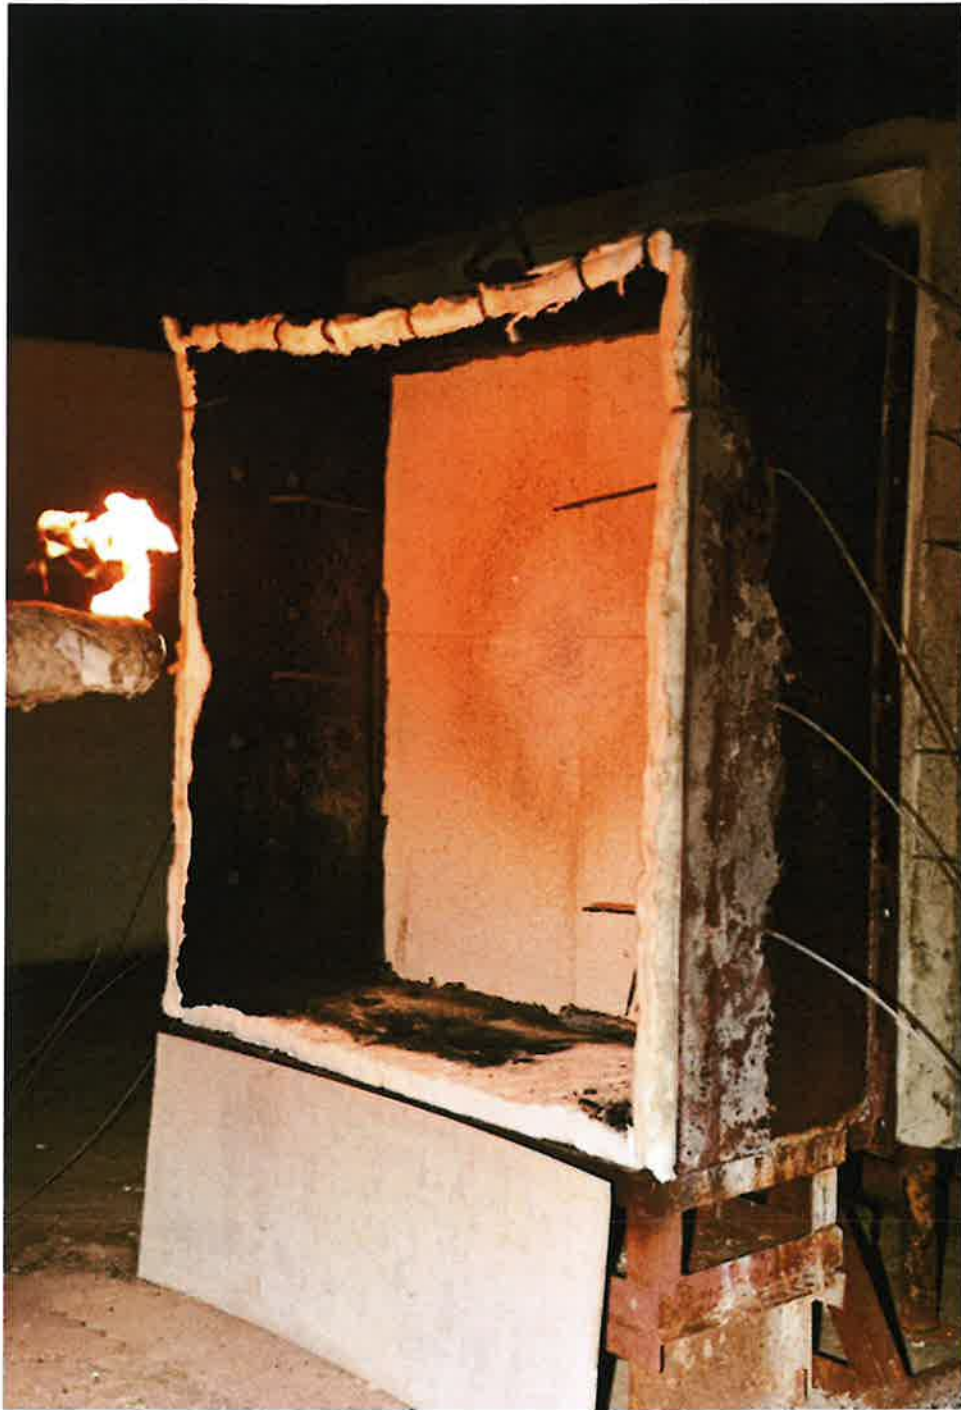
Figure 7: Close up showing condition of exposed face after fire exposure

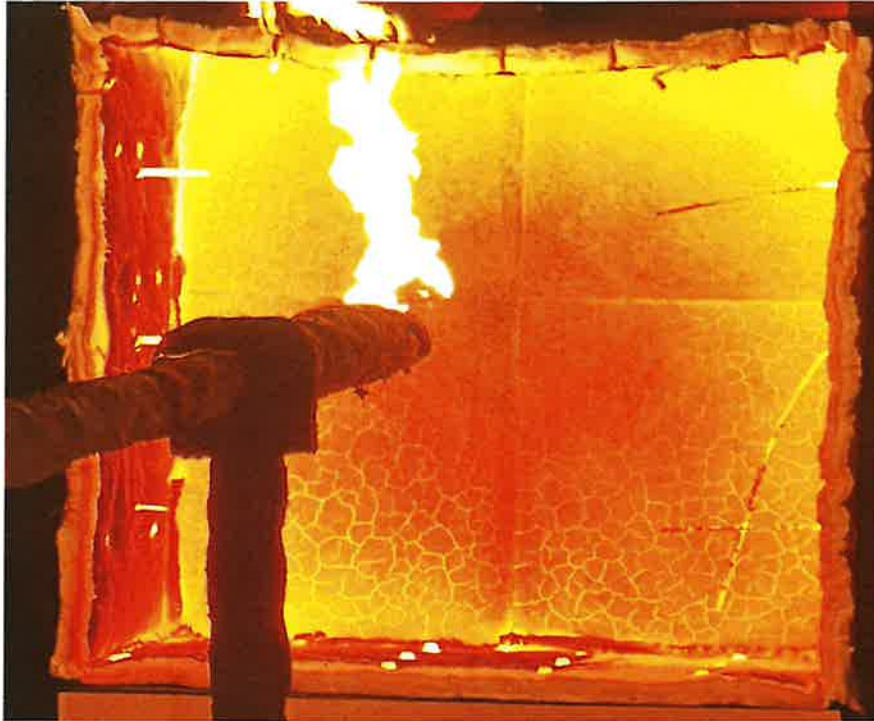
**Figure 8: Close up showing condition of exposed face just after fire exposure:
Cracking pattern on the surface is visible**

- After the fire exposure surface cracks were observed on the all the four quadrants protected with 30 mm, 35 mm, 40 mm and 45 mm U Stucco-FRX protection material.

- The condition of the cracks on the surface of the protection material just after the fire exposure and after few minutes of cooling are shown in Figure 8, and 9 respectively.

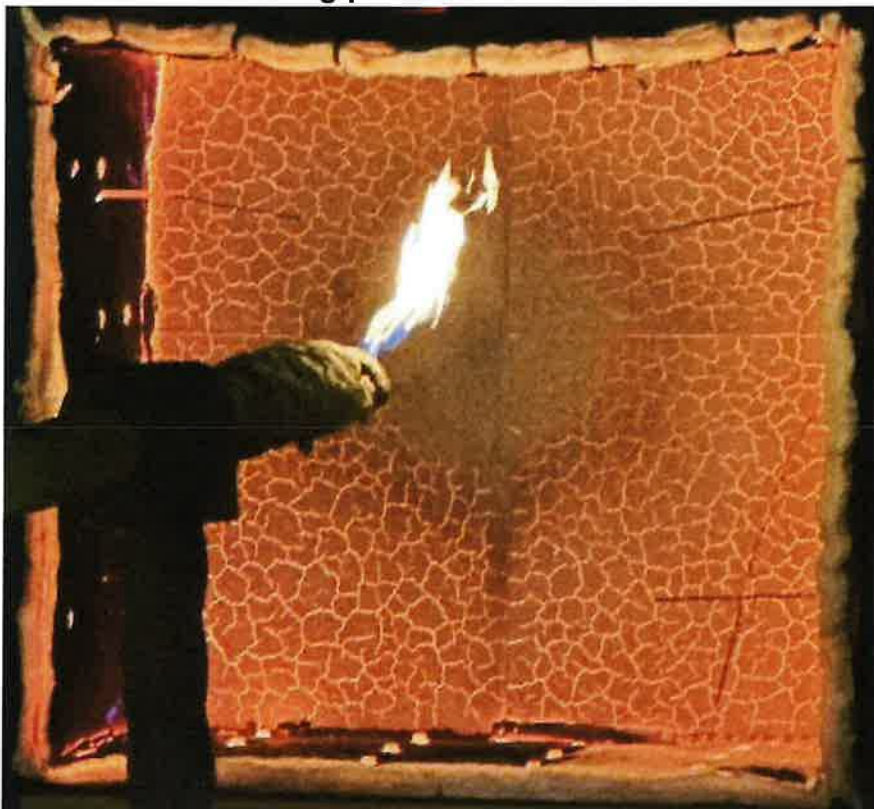
**Figure 9: Close up showing condition of exposed face after few minutes of
shutting off the burner**

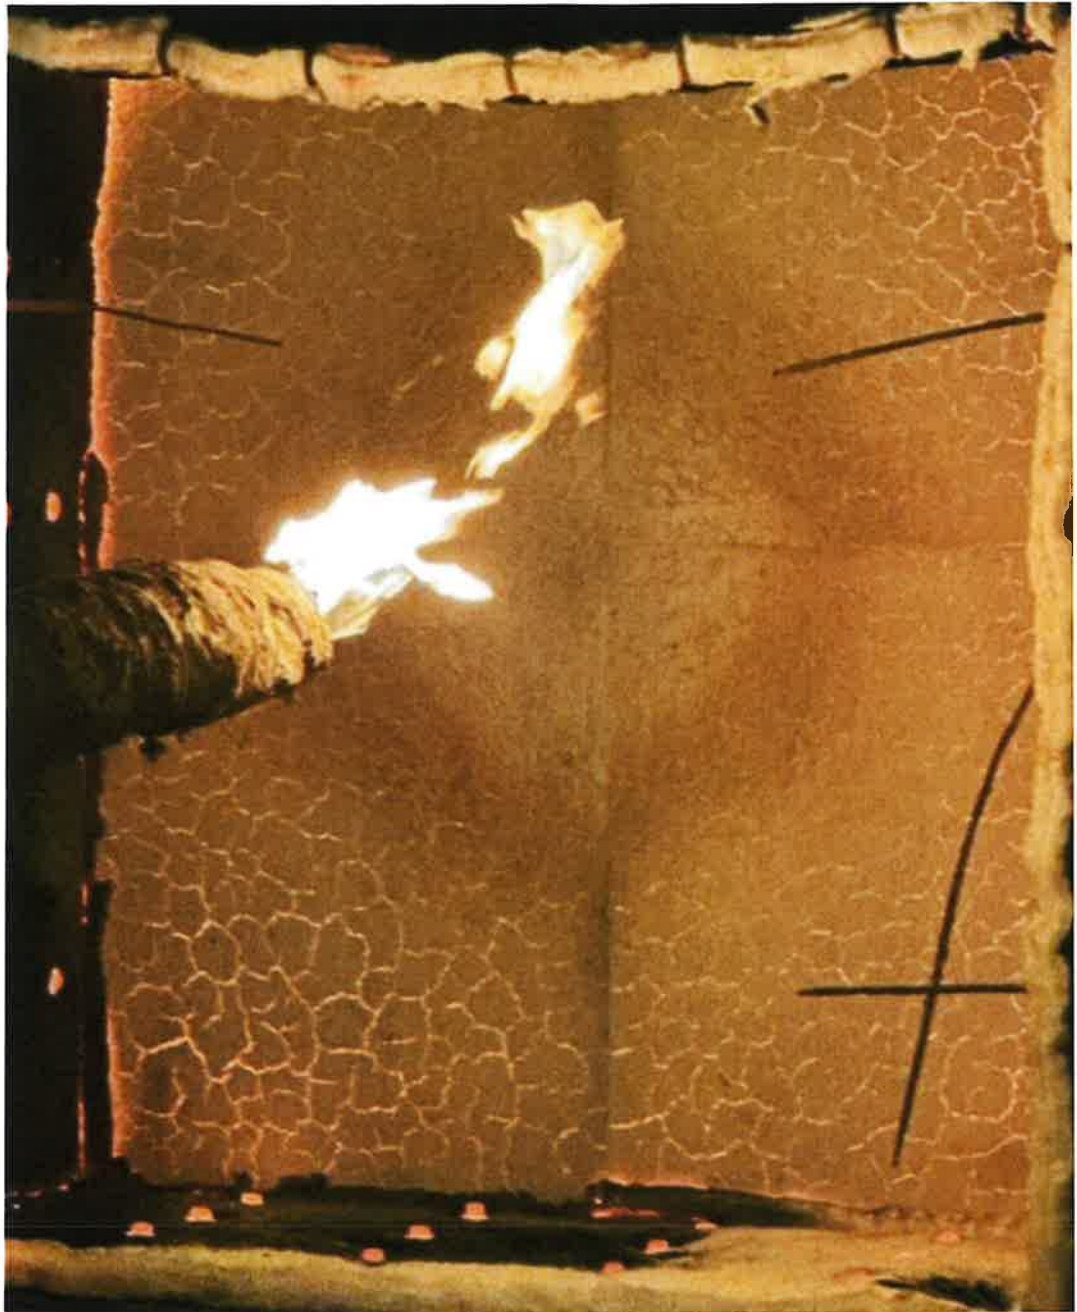
Figure 10 Close up showing condition of exposed face of the specimen during cooling.

- No further cracking and widening of cracks took place during cooling and after attaining the ambient conditions as shown in Figure 10 and 11 respectively.

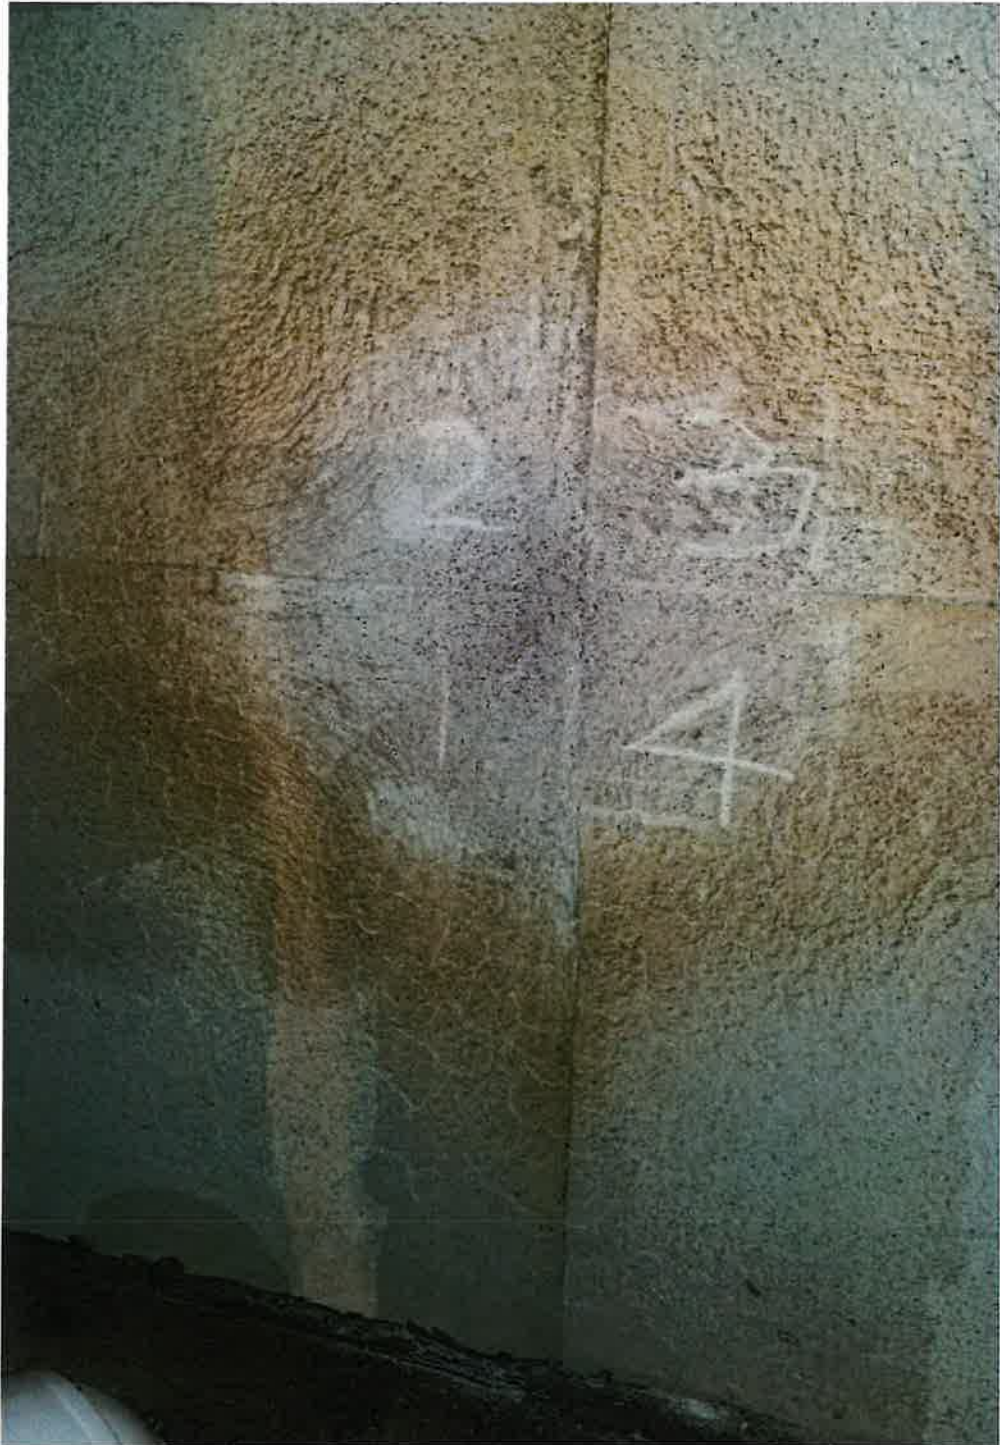
Figure 11 Close up showing condition of exposed face after attaining the ambient condition on exposed face

- When the specimen cooled down to ambient condition, it was observed that the depth of cracks was around 15 to 20 mm.
- To observe the condition of protected surface of concrete after fire exposure, chisel and hammer was used to remove the exposed layer of insulating material i.e. U Stucco-FRX. It showed that U Stucco-FRX insulating material has sufficient strength after 120 minutes of jet fire exposure.
